## **Regular Meeting of the Board of Trustees - April 26**

**April 26, 2022**

# FACILITIES MASTER PLAN

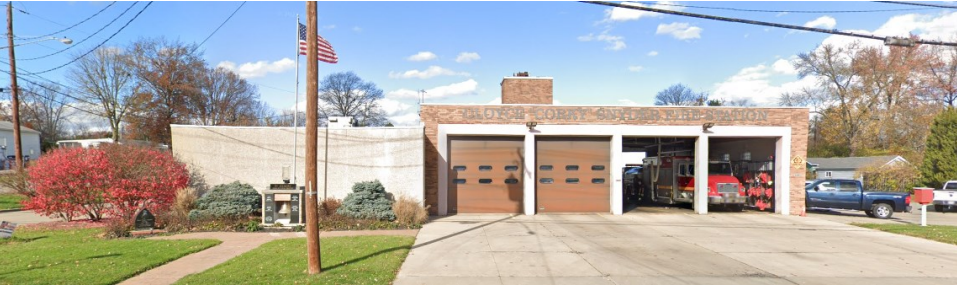
Fire Station 26 is located at 3360 W. Galbraith Road. The facility is a single-story structure on the residential side and a (4) four bay apparatus bay, two of which are pull through. The facility has a brick exterior with concrete accents at the apparatus bay door openings. The station also incorporates a memorial on the Galbraith Road elevation. The roof over both the residential side and apparatus bay is a low slope membrane roof. The primary structure appeared to be structural steel bearing on CMU walls. The station current shift size is 9 with a future shift size anticipated at 10-12.

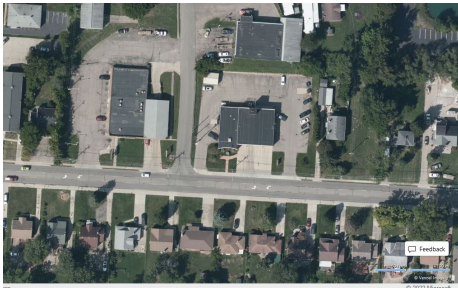
Site Aerial

Three access points to the site are located on Galbraith Road. The easternmost is the main drive aisle access point, which provides access to the site and parking. The drive aisle appeared to be one-way through the site, wrapping around the station and exiting at the westernmost access point. The westernmost access point is directly adjacent to Stahley Drive. With the drive aisle and Stahley Drive coming together, it creates an undesired situation if both are being used. The middle drive is the apparatus bay apron. These access points are part of one continuous curb cut and are separated by small areas of greenspace. The apparatus bay apron south of the bay is concrete paved, while the remaining site parking and drive area is asphalt paved. The concrete apron extends from the station to the street, providing enough room for parking apparatus. Cracked and spalled concrete was observed at the apron and repair or replacement is needed. The asphalt paving shows signs of cracking, requiring repair or resurfacing. With the

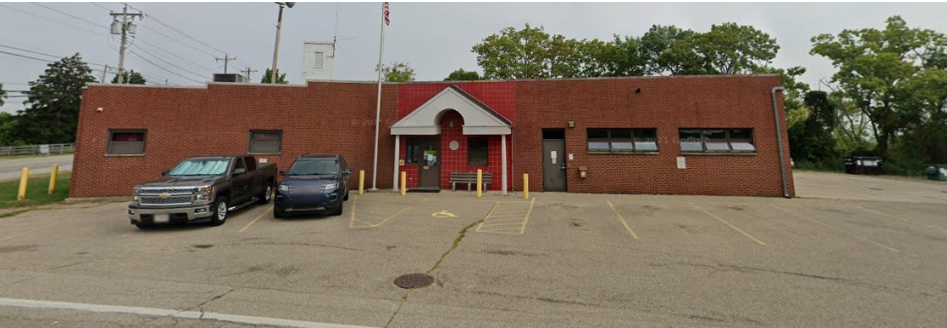
Fire Station 102 is located at 11474 Colerain Avenue at the intersection with Kemper Road. The facility is a single-story structure at the residential side and a (4) four bay apparatus bay, one of which could be pull through. The facility is primarily brick and painted CMU exterior, with glazed tile at the main entry to the facility. The original structure has been modified from its original use and additions were constructed for additional apparatus bay space. The roof over both the residential side and the apparatus bays is a low slope membrane roof. The primary structure appeared to be structural steel bearing on CMU walls. The station current shift size is 4 with a future shift size anticipated at 5-7.

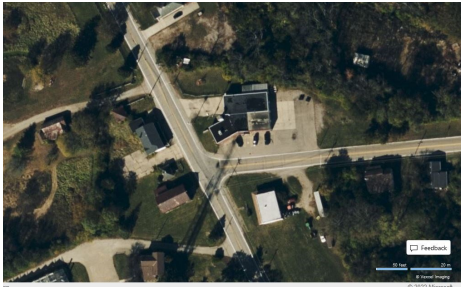
Site Aerial

Main site access off Kemper Road, with connection to the pull-through apparatus bay off Colerain Avenue. The main site ingress provides access to parking at the main entry to the facility and the back-in apparatus bay to the east. Both apparatus bays have concrete paved aprons which extend far enough from the station for outside parking of the apparatus if necessary. Cracked and spalled concrete was observed at the apron and repair or replacement is needed. The remaining drive aisle parking area is asphalt paved. A small gravel over-flow parking area and grass yard sits on the eastern portion of the site. The asphalt drive aisle has been patched and repaired in several areas and has grass growing between cracks. These areas would require additional repair. Parking with a designated accessible stall was observed along the south of the facility, however, ADA signage was missing. The accessible parking was adjacent to the main pedestrian entry to the station.

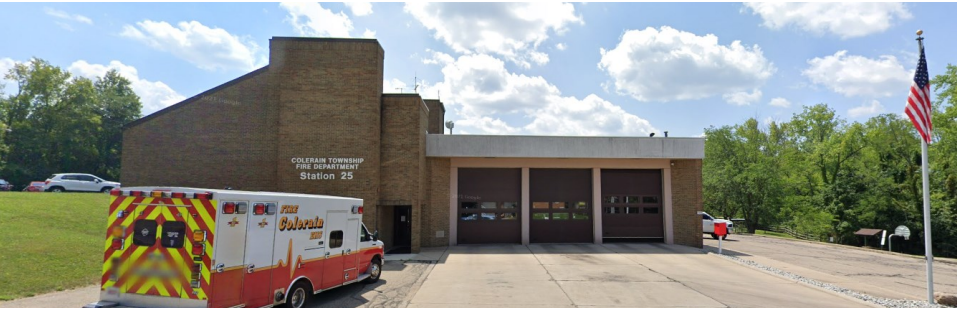
Fire Station 25 is located at 3251 Springdale Road. The facility is a combination of a two-story structure containing the residential side uses, and a (3) three bay pull-through apparatus bay. The facility has an all-brick exterior with a stucco cornice at the apparatus bay. The residential two-story structure has an asphalt shingle gable roof, while the roof of the apparatus bay is a low-sloped membrane roof. The primary structure appeared to be structural steel bearing on stacked CMU walls. The station current shift size is 10 with a future shift size anticipated at 12-15. Charles Palm Memorial Park is located directly west of the fire station.

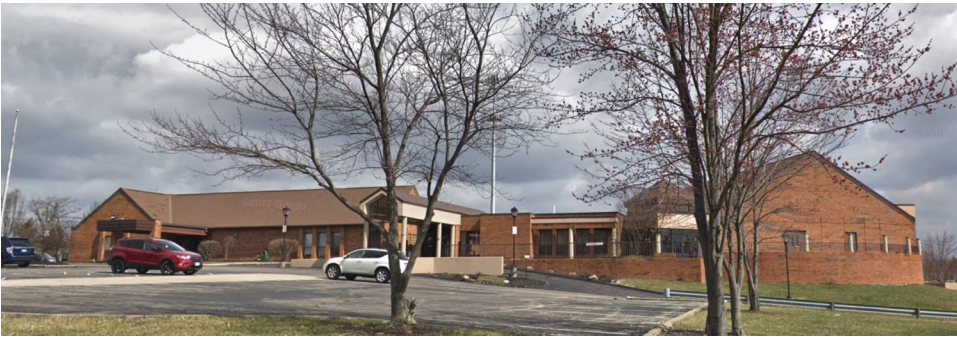
The Senior & Community Center is located at 4300 Springdale Road. The facility is a single-story structure consisting of two wings and a central courtyard. The senior center is located in the west wing and has a central courtyard. The community center on the east wing has a lower level for storage that is only accessible from the outside. The exterior is mostly brick masonry with stucco accents. The majority of the roof is a shingled sloped roof with gables. A portion of the community center east wing is a low-sloped membrane roof. The building has two gabled entry canopies which may confuse someone unfamiliar with the facility.

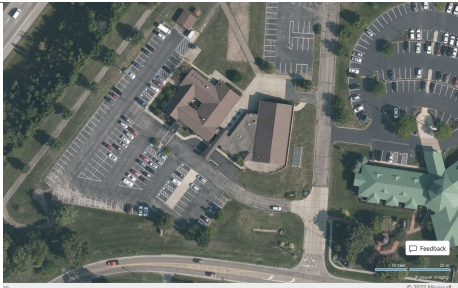
Site Aerial

Site access is on the south of the site directly off Springdale Road via Dale Woods Way. Dale Woods Way provides direct access to the primary parking lot. Dale Woods Way and the Center’s parking lot are asphalt pavement. Parking is also available on the west and north sides of the facility. In general, the drives and parking lot are showing signs of aging, with cracks and repairs observed throughout. Repair, resurfacing, or replacement is likely needed within the next 5 years. The lot to the north behind the community center is in the most need of attention. Accessible parking was adjacent to the main pedestrian entry to the facility on the south side of the building. Designated accessible stalls with appropriate signage were observed.

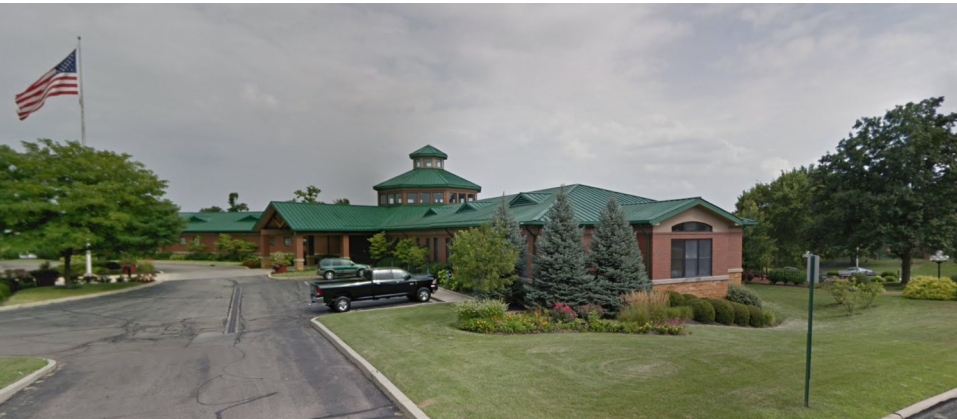
The Colerain Township Government Center Building is located at 4200 Springdale Road and houses the Township Administration, Police Department, and Trustee Hall. The facility is a single-story structure with a partially underground lower level and a walk out to a courtyard in the front of the building. The building consists of three prominent wings, each coming together at a central rotunda. The Police Department is located in the east wing, Township Administration in the west, and the Trustee Hall in the south. The exterior is a combination of brick, stone, and stucco; the primary level being brick and lower walk-out level stone. A concrete accent band separates the brick from the stone. Stucco is located as a narrow band at the top of the brick below the building overhang/soffit, as well as at the gables. The exterior of the rotunda is a combination of square windows, brick, stucco, and includes a cupola above. The main rotunda consists of windows and brick, along with a narrow band of stucco above. The cupola is a combination of windows and stucco. The roof over the entire facility is a standing seam metal roof. The building also includes a large gabled entry canopy, easily identifying the entrance.

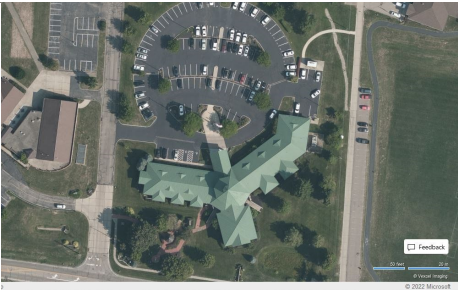
Site Aerial

Site access is on the south of the site directly off Springdale Road. There are two access points along Springdale Road for the campus. The westernmost is the main drive access point, Dale Woods Way, which provides access to the site and parking. The eastern drive aisle is a one-lane drive, leading up to the Fire Department Headquarters and Service Building before connecting to Dale Woods way. Dale Woods Way and the Township Office parking lot are mostly asphalt pavement with a small section of concrete near the entrance adjacent to the senior center concrete parking lot. Parking is available on

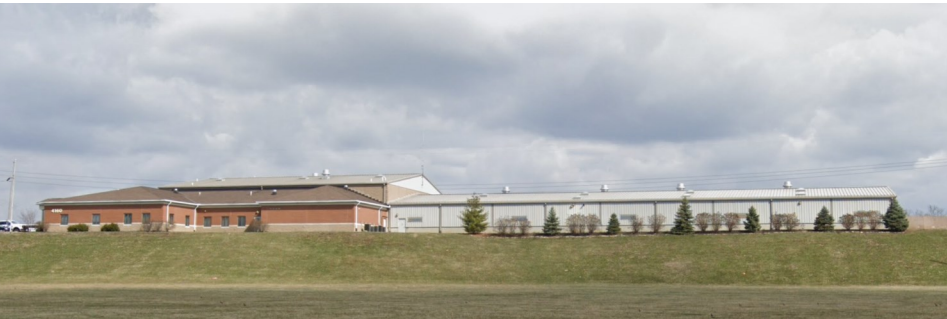
The shared Public Services and Fire Department Headquarters building is located at 4160 Springdale Road and is a single-story structure including an adjacent high bay. The facility is separated into three distinct wings. The fire department headquarters is located in the south wing with exterior walls composed of brick with a split face masonry base. This south wing also includes a hipped roof with gabled entry. The public service offices are split between the south wing structure and high-bay to the north. This north high-bay is the tallest of the three wings and includes a mezzanine storage area. The exterior is a combination of brick, split face masonry, CMU block, and metal panel with a metal roof. The east wing is a vehicle storage area and is a pre-engineered metal building with metal panel exterior wall finish and a standing seam metal roof.

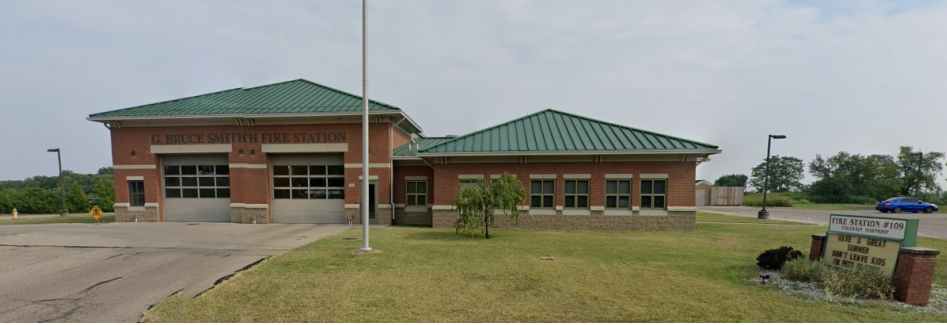
Fire Station 109 is located at 2850 W. Kemper Road. The facility is a single-story structure on the residential side and a (2) two bay apparatus bay, all of which are pull through/tandem. The facility has a brick exterior with a split faced CMU base, cast stone water table, and cast stone windowsills and headers. The roof over both the residential side and apparatus bay is a gabled standing seam metal roof. The station current shift size is 5 with a future shift size anticipated at 5-7.

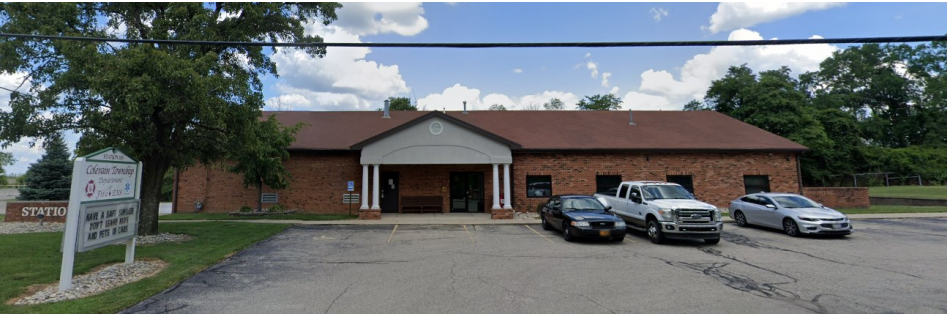
Fire Station 103 is located at 6000 Thompson Road, at the intersection with Springdale Road. The facility is a single-story structure at the residential side and a (3) three bay apparatus bay, all of which are back-in type, with the center bay providing higher clearance. The facility has a brick exterior. The roof over both the residential side and apparatus bay is a gabled asphalt shingle roof. The station current shift size is 5 with a future shift size anticipated at 5-7.

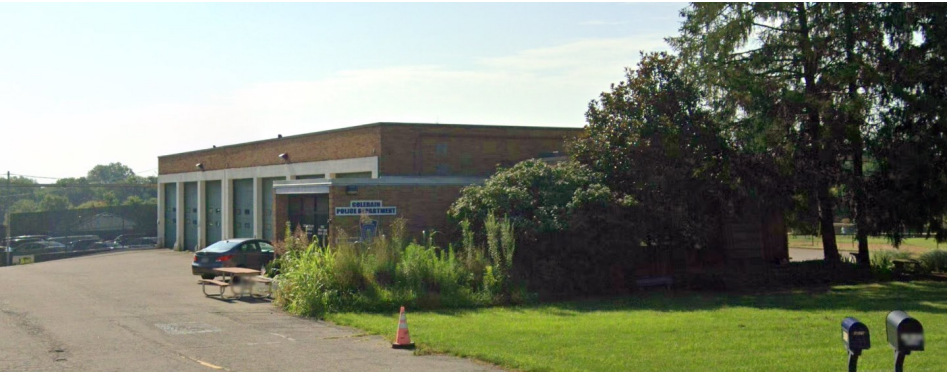
The Impound Lot and Historical Society is located at 4669 Springdale Road. The facility is a single-story structure at the impound office and Historical Society and has a (7) seven bay garage, all of which are back-in type. The three easternmost bays are deeper than the other four. The facility has a primarily brick exterior, with a concrete portal at each of the garage bay doors. The roof over the entire facility is a low slope membrane roof. The site is adjoined on the north, east and south by Colerain Park and on the south by Colerain Elementary School.

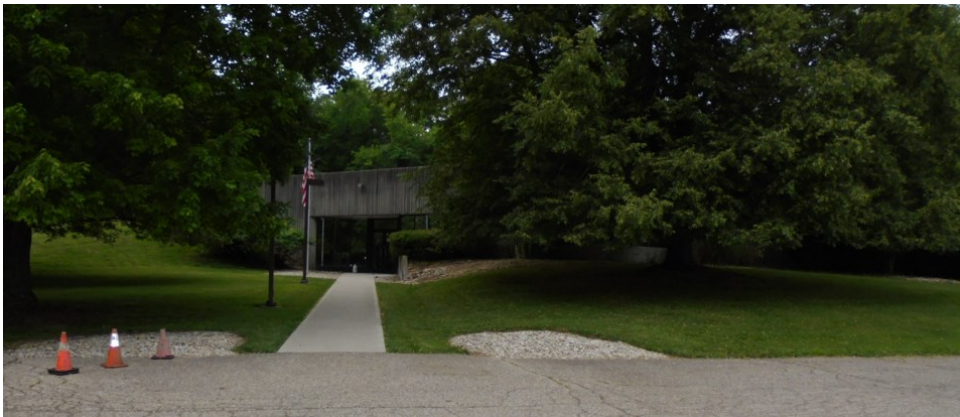
The Training Center is located at 11865 Colerain Avenue. The facility is a single-story structure which is partially built into the landscape due to the slope of the site. The facility is primarily concrete cast-in place panels. A majority of these panels have a decorative vertically ribbed profile. The roof is low slope covered with a ballasted membrane roof. This facility is served using a grey water system.

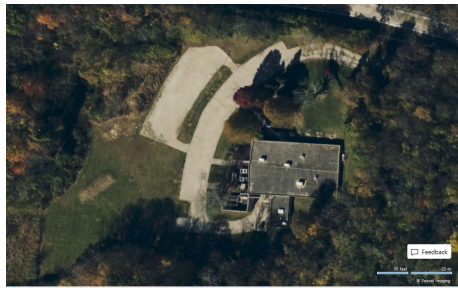
Site Aerial

Site access is on the north of the site off Colerain Avenue. The building and parking are set back from the road and accessed via an asphalt paved driveway. The site is more rural and has open greenspace adjacent to the parking area, but is surrounded by a wooded area. As the driveway enters the site, it proceeds up a hill to the parking and building access. Paved parking is provided with a gravel overflow lot adjacent to the west of the building. Parking stripes were faded or non-existent and an accessible parking stall was not observed. The drive continues past the building and provides access to the mechanical yard and delivery area which are on the south and southwest side of the facility. The site does have green open space adjacent to the parking and at the north side (main entry) of the facility. Caps to what are assumed to be buried tanks and warning signs noting to keep lids secured were observed in the open greenspace areas. Site lighting was not observed. A gravel drainage swale was on the east side of the site where the building is built into the landscape. Further investigation would be required to determine if any buried drainage pipes are present.

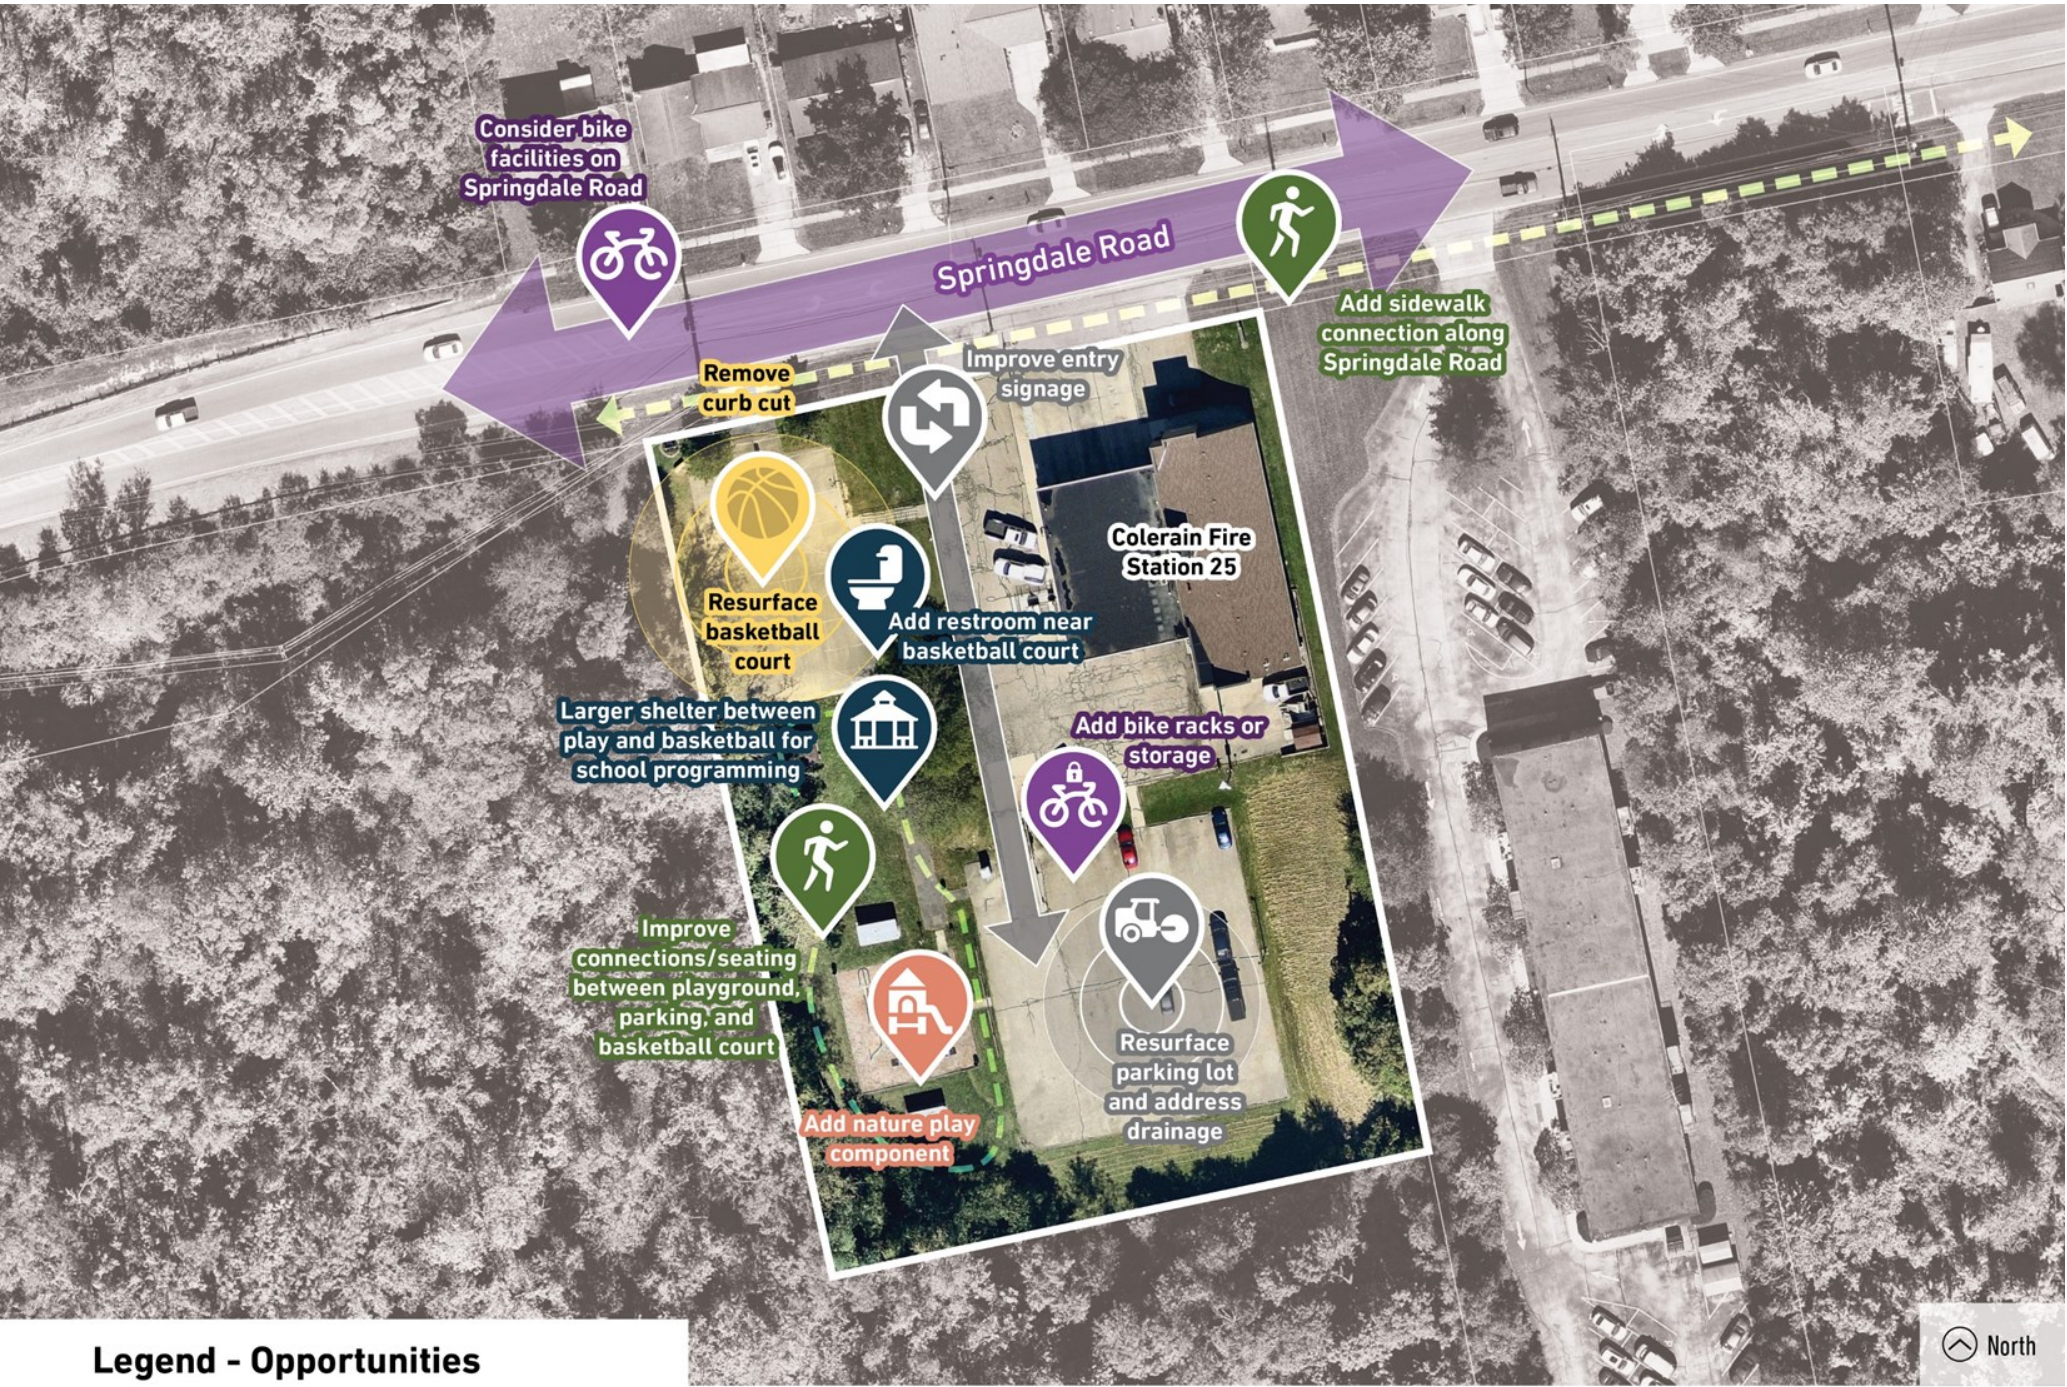
Though small in its footprint, Charles Palm Memorial Park provides meaningful neighborhood-serving amenities, such as a playground and basketball court. However, the park lacks adequate visibility from Springdale Road and suffers from inadequate surface conditions at some of its facilities. As such, the opportunities for this park include:

- Improve park signage and wayfinding near its access drive along Springdale Road.
- Resurface the park's parking lot and address drainage issues with internal landscaping.
- Improve bike connectivity to the park through bike facilities along Springdale Road, connected to other local amenities.
- Resurface the former parking lot now serving as a basketball court, removing the existing curb cut along Springdale Road.
- Provide better buffer between basketball court and Springdale Road.
- Add a nature play component to the existing playground.
- Improve pedestrian trail connections between the playground and basketball court, locating seating areas near improved trails.
- Consider the addition of a larger shelter between the basketball court and playground.
- Add bike racks or storage near the park entrance or in the parking lot.

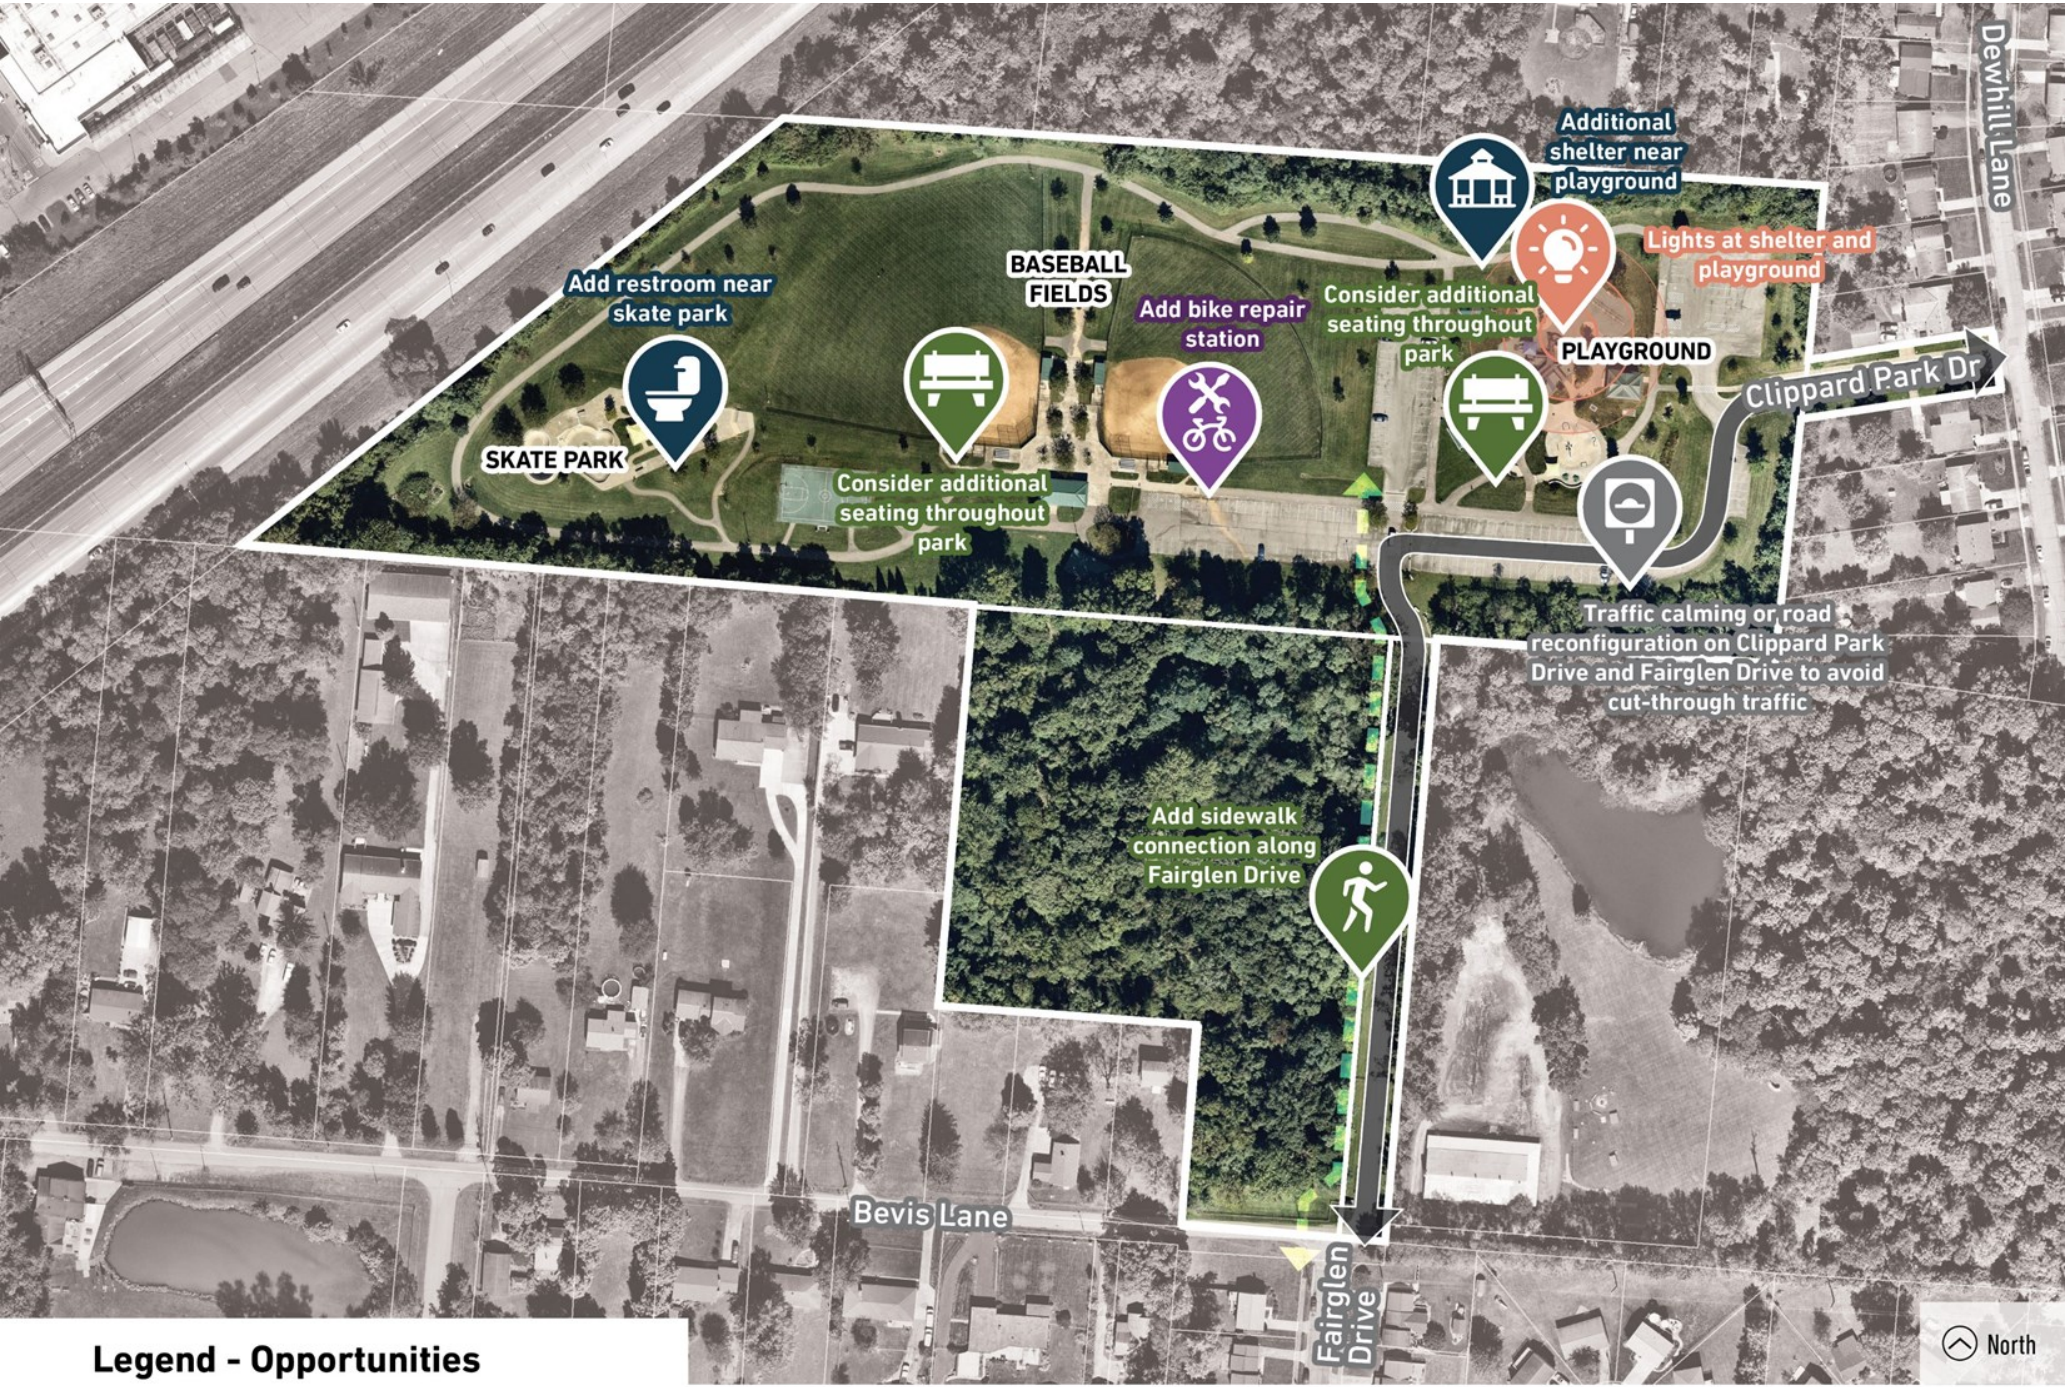
As a community park with regional amenities, such as a skate park and a sprayground, Clippard Park is uniquely situated at the edge of a residential community. The park’s main challenge is a barricade at the driveway between Clippard Park Drive and Fairglen Drive, intended to discourage cut-through traffic. In addition, other opportunities include:

- Address the existing connectivity gap by introducing traffic-calming measures along the park’s parking lot between Clippard Park Drive and Fairglen Drive, or divide into two separate parking areas.
- Improve accessible pedestrian connections into the park by adding a sidewalk at the Fairglen Drive access drive.
- Address perceived safety issues by adding lighting throughout the entire park, with a focus on the playground, sprayground, and skatepark areas.
- Consider additional seating throughout park, both along existing trails and near athletic facilities and amenities.
- Add a restroom near the skate park.
- Add a bike repair station located near existing bike racks.

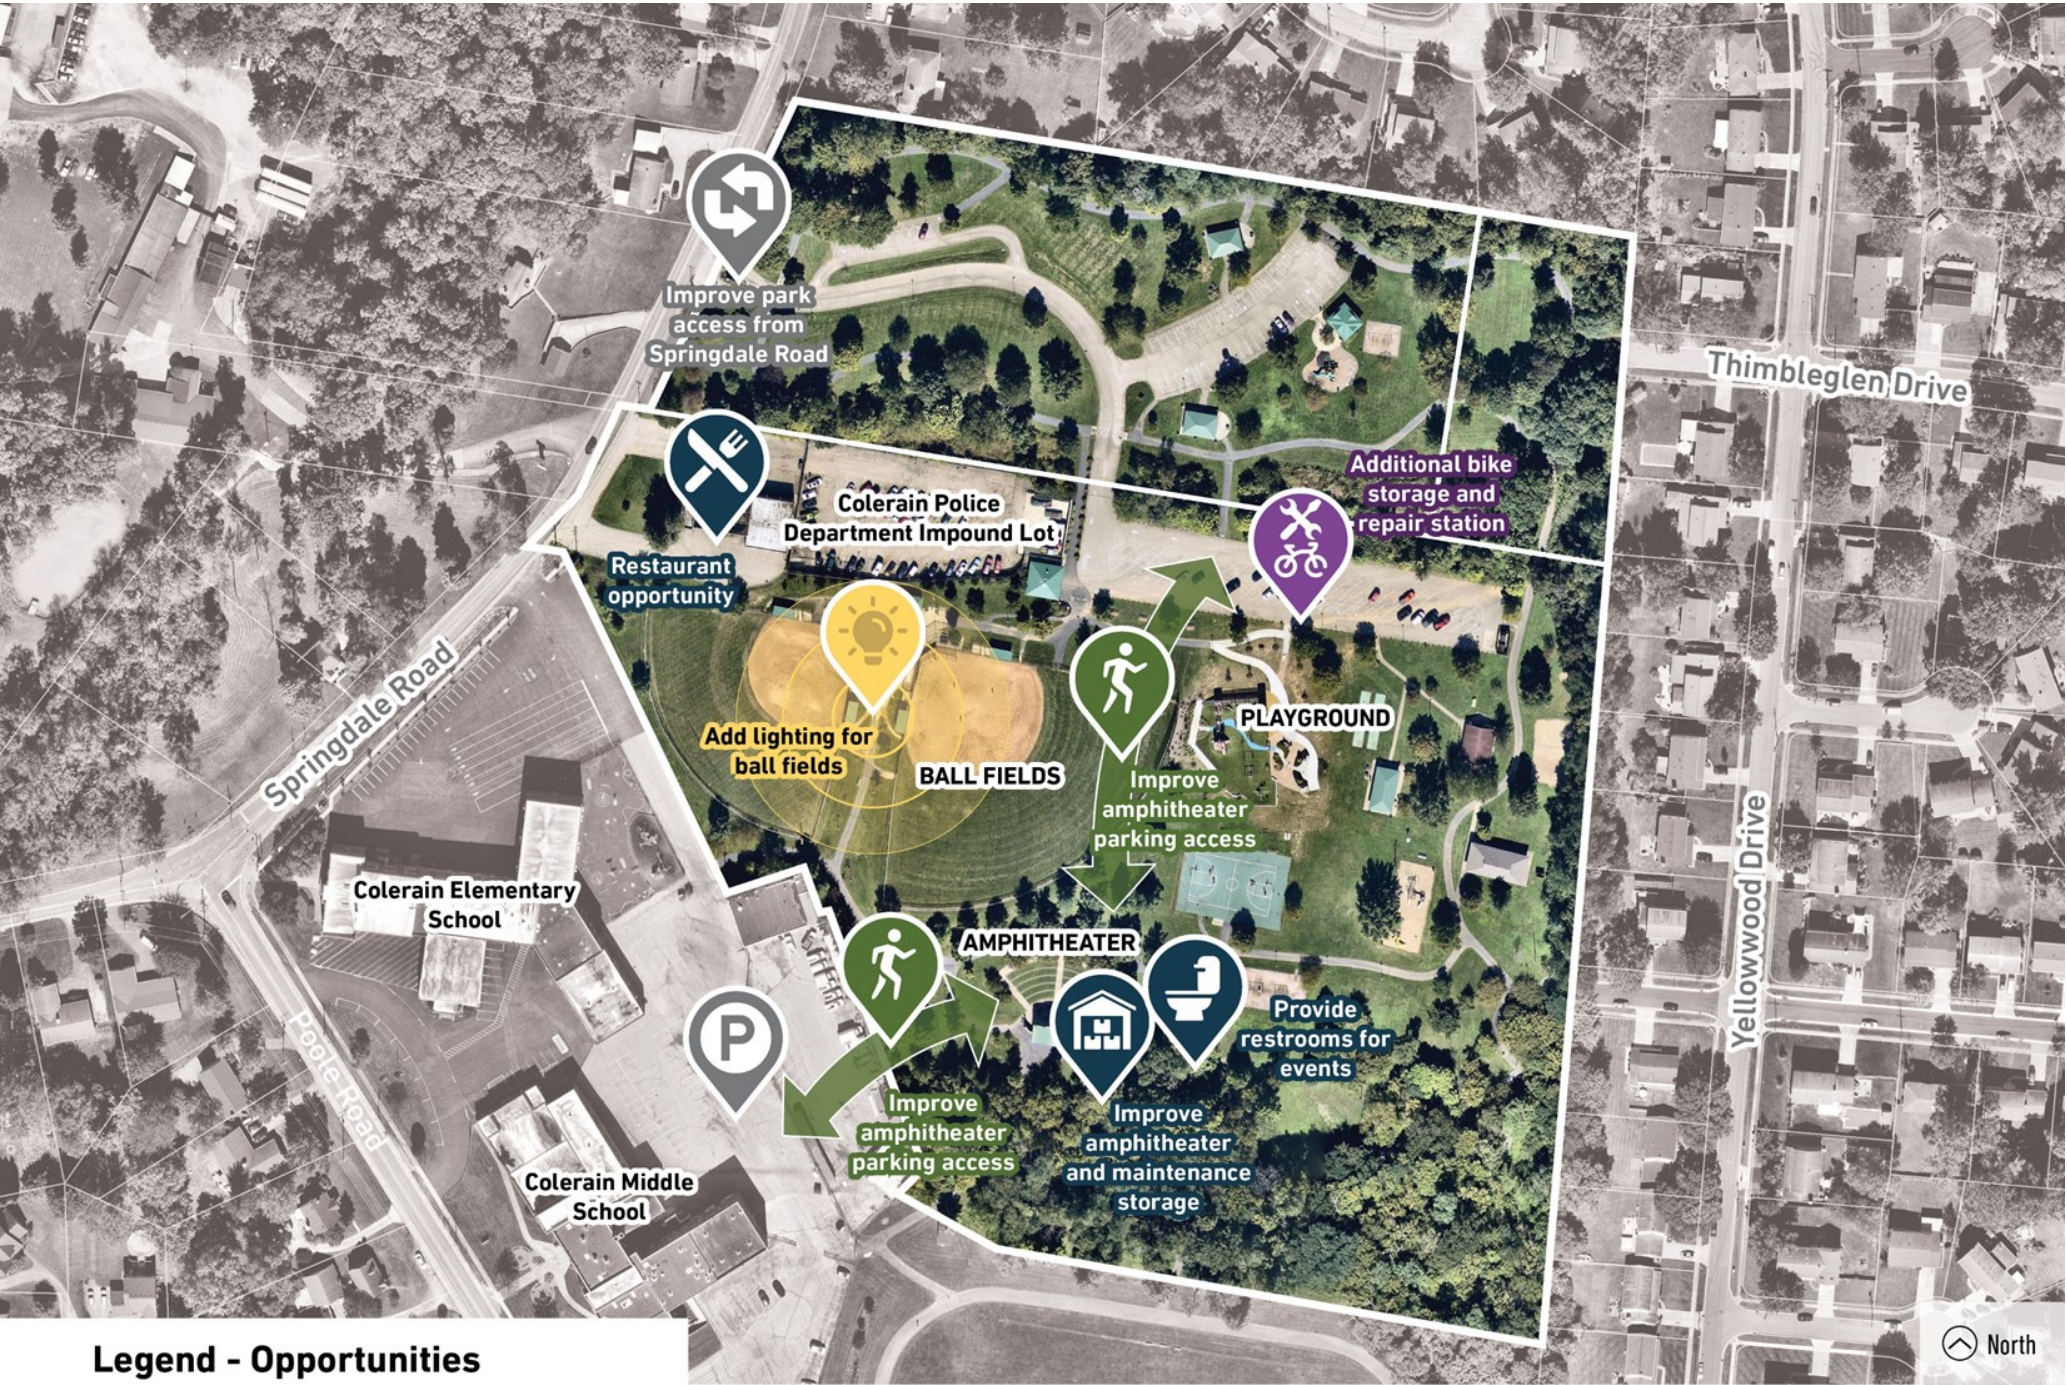
Colerain Park provides a wide array of amenities that serve both nearby residents and the larger Colerain Township community. Well connected to its surrounding community with ample pedestrian entry points, the park's recommendations focus on improving internal connections and facilities:

- Improve pedestrian connectivity, with a focus on accessibility, between the Colerain Park Amphitheater and nearby parking lots.
- Improve storage and maintenance spaces near the amphitheater, to better serve community events and park operations.
- Provide conveniently located restrooms as an event amenity near the amphitheater. Restrooms may potentially include storage or green room space for performers/talent.
- Simplify park access from Springdale Road through better signage and wayfinding.
- Add more bike storage facilities, and a bike repair station.
- Add lighting to existing baseball fields.

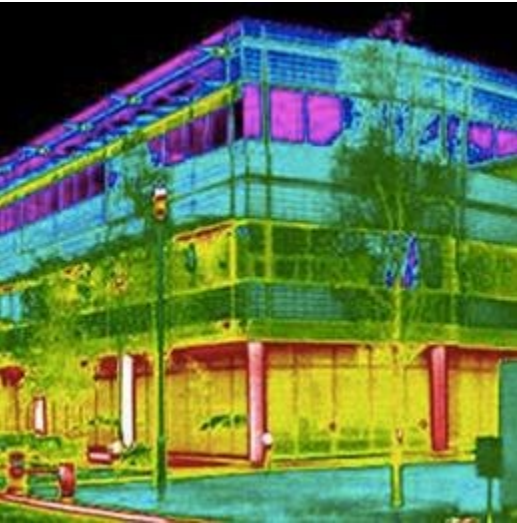
**THERMAL IMAGING INSPECTION** is a method of verifying locations within a building’s façade system where heat is escaping. An infrared camera allows an inspector to identify areas where insulation may have fallen down or been compressed, areas where water or moisture is collecting inside walls, or areas where ducts are losing heat instead of delivering warm air to rooms. Infrared cameras are frequently used during HVAC inspections, to find roof leaks, and identify structural defects.
